# Video observation of encounters between the automated shuttles and other traffic participants along an approach to right-hand priority T-intersection

Petr Pokorny<sup>1\*</sup>, Belma Skender<sup>1</sup>, Torkel Bjørnskau<sup>1</sup> and Marjan P. Hagenzieker<sup>1,2</sup>

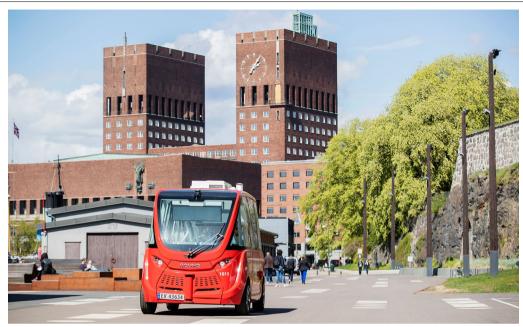
Fig. 1 One of the Navya Arma shuttles operating along Akershusstranda in Oslo (source: https://ruter.no/om-ruter/prosjekter/selvkjorende-kjore tov/)

The type of observed shuttle was Navya Arma (see Fig. 1). In Oslo, the local public transport provider Ruter has been testing these shuttles since 2019 as an integrated part of Oslo region's public transport network.<sup>1</sup>

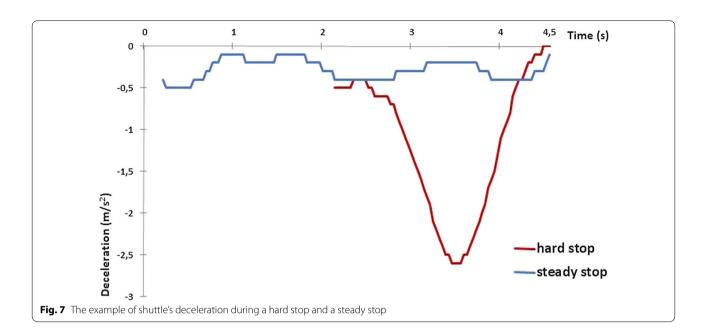
Figure 7 shows the course of the shuttle's deceleration during a hard stop and a steady stop.

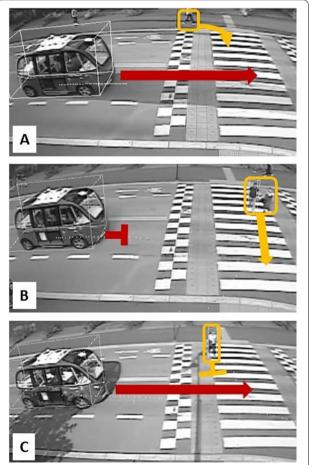
**Fig. 8** The examples of encounters between the shuttle and pedestrians. **a** The shuttle does not react; **b** the shuttle yields, but stops too early; **c** the shuttle does not give a way

crossing from the left (from the view of the shuttle). In one encounter, the shuttle correctly did not yield, since the pedestrian was still in a sufficient distance from the crossing (Fig. 8a). In the second encounter, the shuttle correctly yielded, however it stopped too far from the crossing (Fig. 8b). In the remaining two encounters, the shuttle should have yielded, but it did not, and the pedestrian had to either stop or slow down to let the shuttle drive (Fig. 8c).
